**Duluth & Northern Minnesota Railway Company
Solarium Car #28
Rebuilt May 1994—May 1995 by Greg Vreeland and Assistants
Built by American Car & Foundry in 1912**

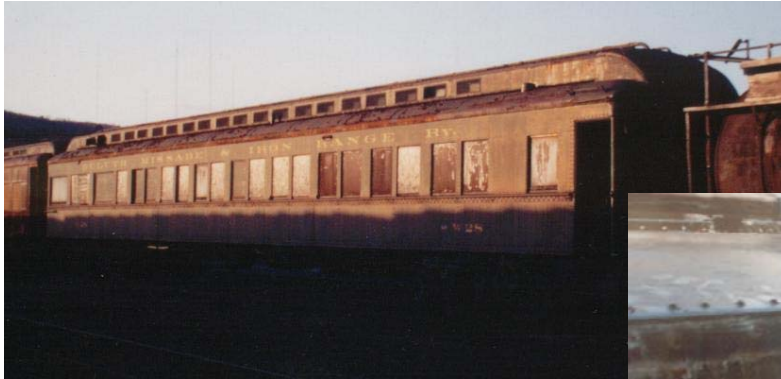
Exterior view of car sitting in storage prior to being acquired for rebuild. Car had been used in revenue service through early 1960's, in maintenance service through 1970's and in storage since 1980. Fifteen years of neglect had taken its toll.

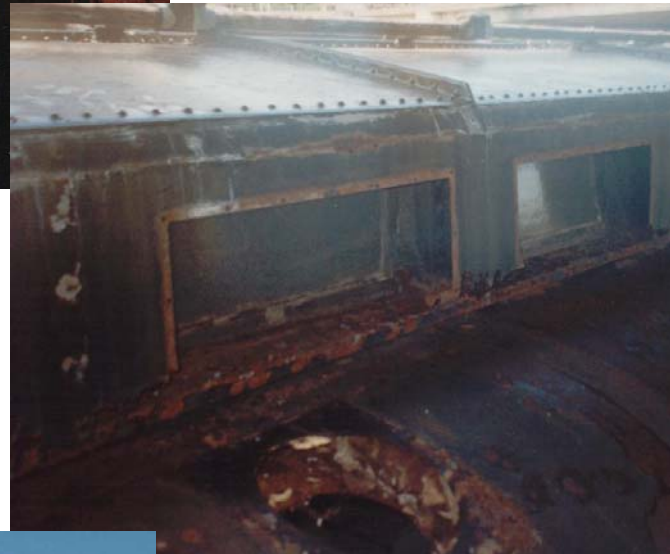
Large hole in roof was result of a stove pipe being removed as some point. Steel sheeting was paper thin along much of the hip area of the roof.

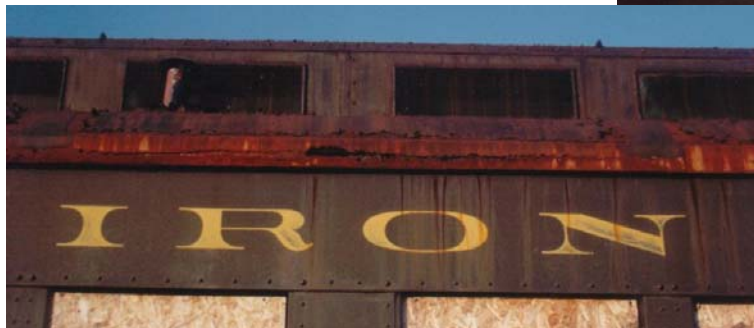
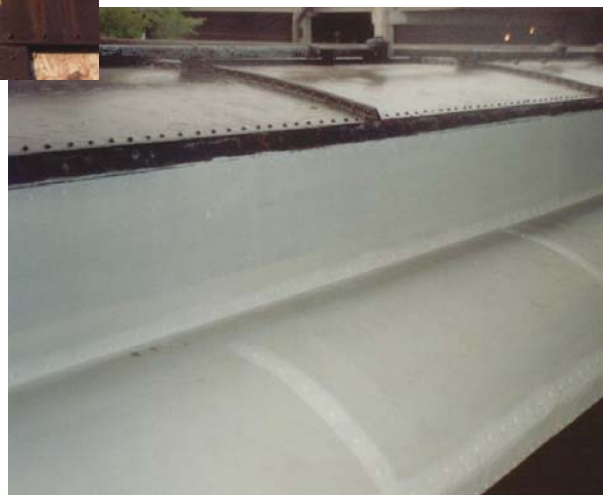
Roof edge was rusted completely through along most of the length of the car. This allowed a substantial amount of water to penetrate the walls destroying much of the original mahogany woodwork. Photo at right shows the completed metal work. Approximately 60% of the roof was replaced. Following the installation of the new galvanized sheeting it was painted with a special primer, all joints and fasteners were sealed and the roof received a new paint job.

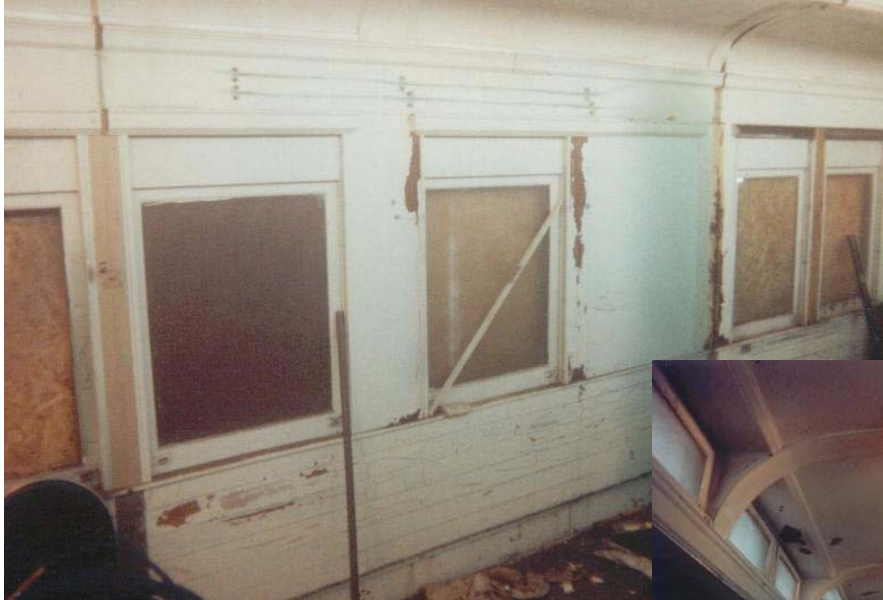
Interior view of car at beginning of project. Note the many layers of paint covering the mahogany woodwork. Also note the missing trim work. All remaining woodwork was stripped of paint and then examined for reuse. Much of it was water damaged beyond salvation.

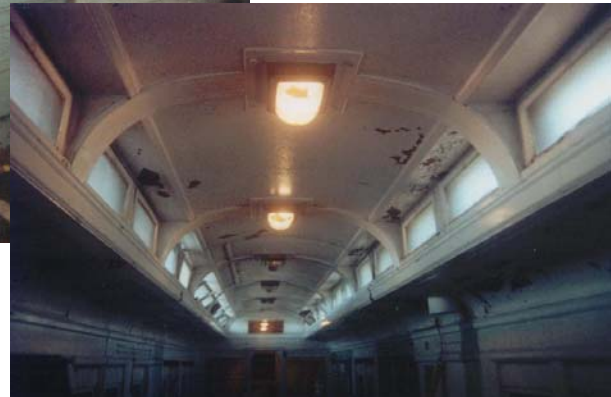
Metal ceiling was sandblasted, repaired, primed and repainted using Dupont Imron. This durable paint works well in the northern climate because it is designed for harsh environments and stands up well to changes in temperature.

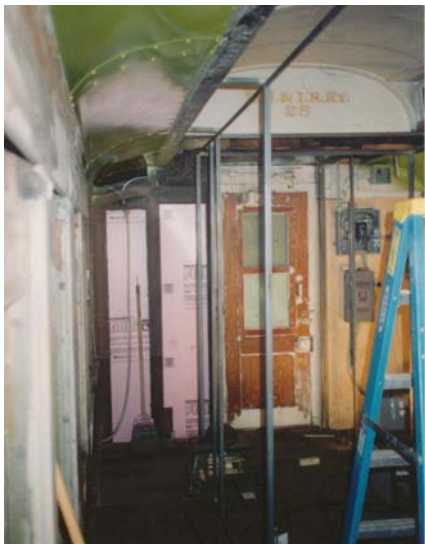
Construction of interior walls was accomplished using a framework of angle iron for strength and mahogany plywood for the sheeting. Steel frame was painted mahogany brown and then the panels were stained.

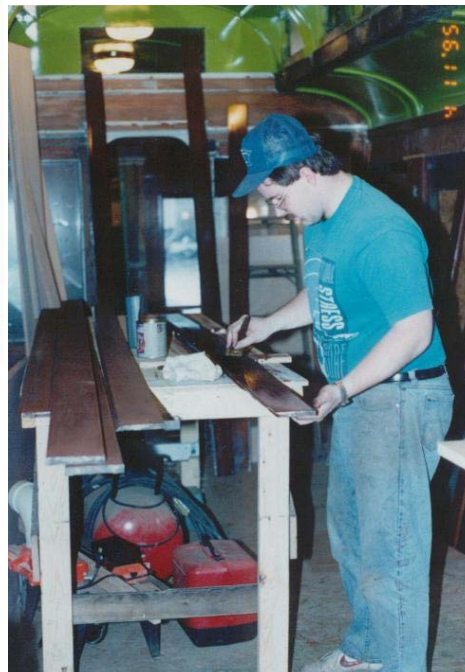
At beginning of project car was completely stripped. During project walls were added to create a restroom, storage closet, mechanical/furnace room, buffet kitchen, and an open bar. Tables were added in the main body, and overstuffed lounge chairs in the solarium. Original woodwork was used whenever possible and new mahogany added where needed. New wood was stained to blend with original.

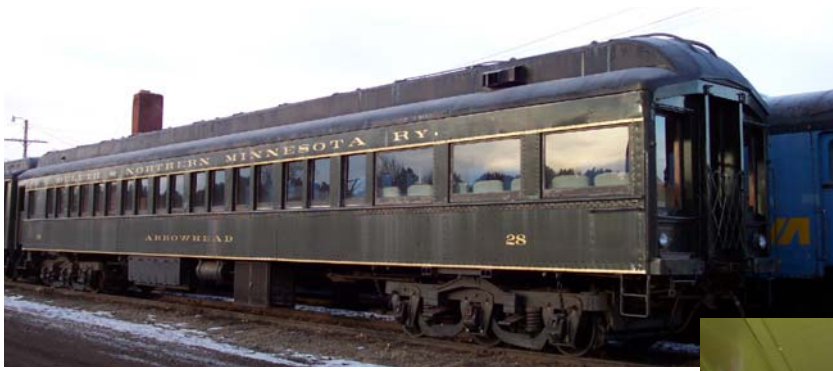
Exterior view of completed car in service on the Wisconsin Great Northern Railroad in Spooner, Wisconsin.

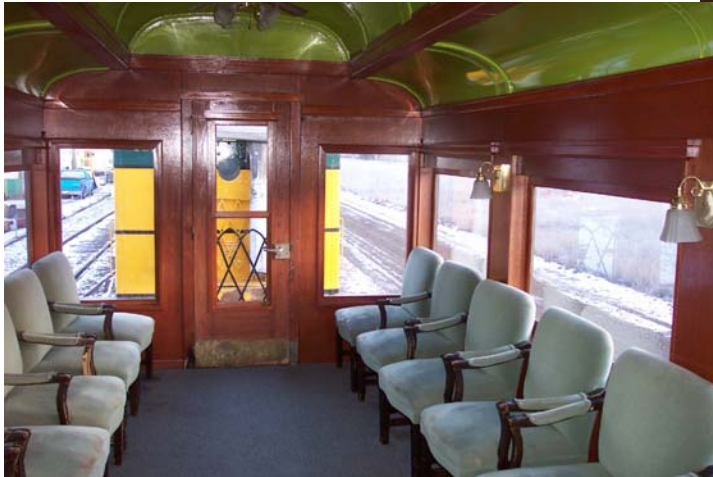
View of the Solarium end of the car. All of the window frames and 100% of the woodwork in this room is new. It has been matched to the rest of the car in both style and coloring.

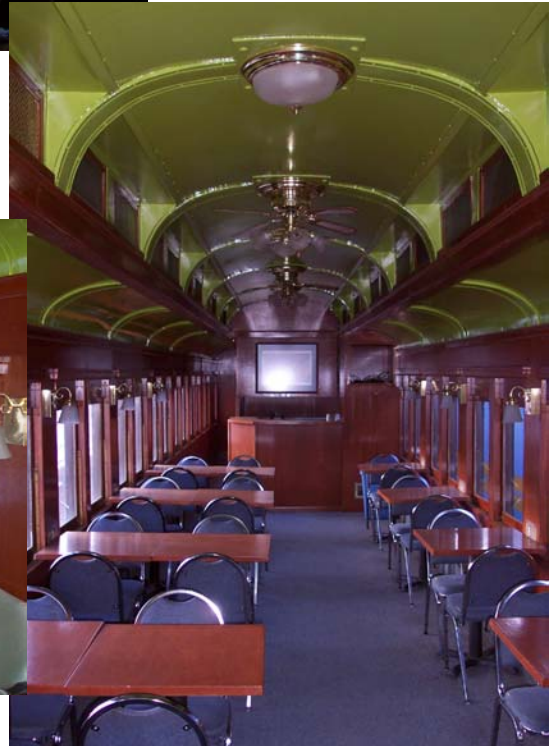
The photo at left shows the completed hallway. Note the rich finish on the mahogany plywood and the trim work and stylish light fixtures.

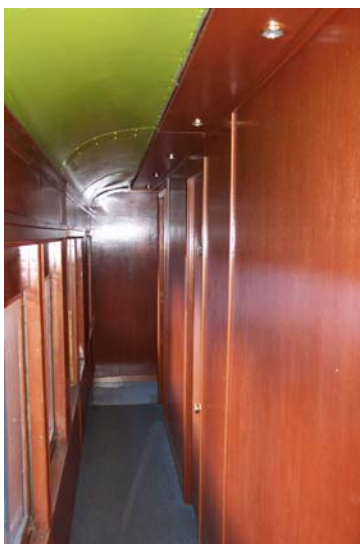
The photo at right shows the newly built partition that separates the solarium from the main dining area in the middle of the car. This car was built specifically for private parties and can comfortably seat up to 42 guests.
